<p>IAGC STEP CHANGE INITIATIVE LAND SESIMIC</p> <p>HSE ALERT HIGH POTENTIAL INCIDENT (HiPo)</p>	 
---	---	---

Alert Issued:	August 29, 2008

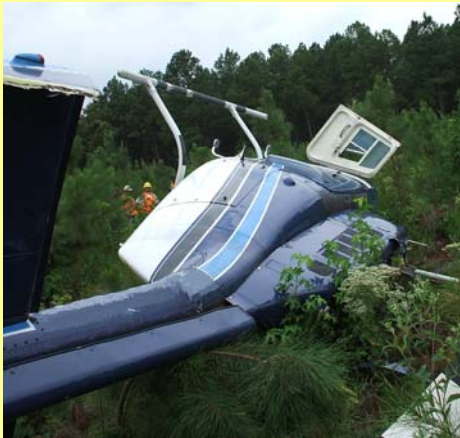
</div>		
Conclusions:	<p>The Federal Aviation Administration (FAA) was notified about the incident and an investigation was initiated. The FAA's investigation was assisted by the helicopter company's on-site mechanic. The preliminary result of the internal investigation was that the air line between the fuel control and governor became disconnected, allowing erroneous information between the two components which resulted in the engine spooling down to idle.</p> <p>While there is no conclusive evidence to show what caused the air line to become loose and eventually disconnect, the air line was recently removed during maintenance work on the turbine. However; the aircraft was flight tested after the maintenance was completed and no problems were</p>

<p>reported.</p> <p>The cause for a fitting to become disconnected could be inappropriate torque and/or exposure to vibrations over time. The typical indication for the fitting slowly backing off would be noticeable engine power surges. However, this indication was not evident and no engine problems were reported a week into the operation after the engine maintenance. It is not yet determined why the sudden air line disconnected without any previous indications.</p> <p>Immediate action taken: All company pilots and mechanics were notified regarding the preliminary findings. They were instructed to visually inspect all air lines for signs of air leakage and manually examine the torque on all air line fittings. Mechanics were instructed to apply torque stripes to all air line fittings after checking for proper torque.</p> <p>Long-term action taken: After any major engine work involving the pressurized air lines, the standard procedure of cross-checking a mechanic's work will be enhanced by applying two torque stripes in different colors. The primary mechanic will mark the fitting after applying appropriate torque. The second mechanic cross-checking the appropriate torque will apply another stripe in a different color.</p> <p>Torque stripes are visual indicators for the pilot during the preflight. A mis-aligned torque stripe will indicate movement of the fitting that must be brought to a mechanic's attention.</p> <p>The helicopter company also took the opportunity to review its internal ERP procedures and worked with Global's crew management and HSE officers to enhance the overall emergency procedures for a downed helicopter.</p>
